OED-S13076-1T

REV. A

PHOTO INTERRUPTER, 1 TAB.

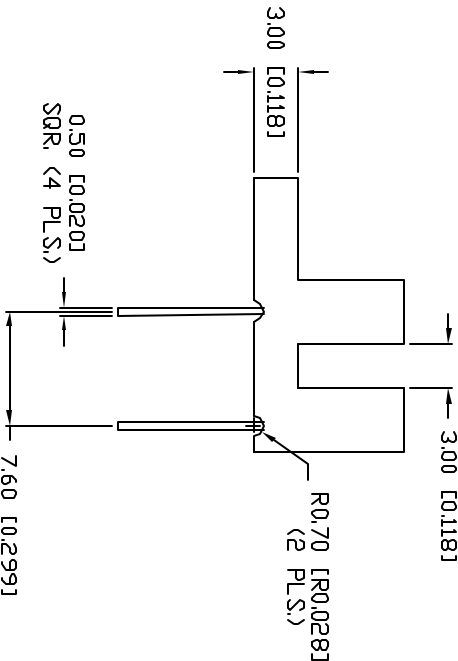
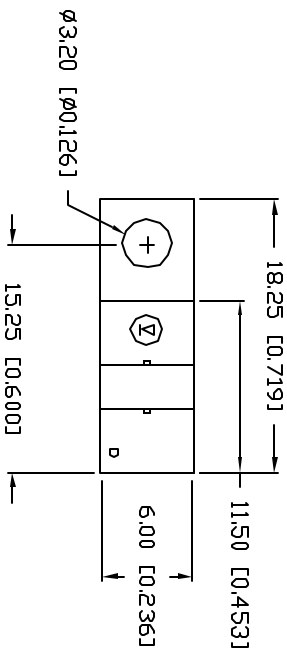
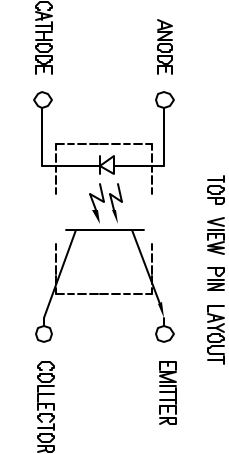
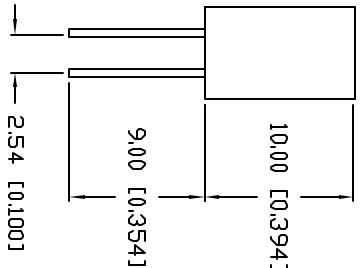
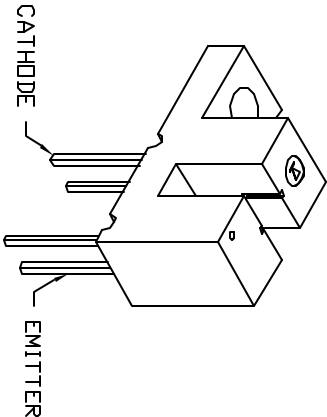
- NOTES:
- MADE FROM OED-S1306-2T.  
CUT OFF TAB AS SHOWN.
