PART NUMBER  
SSI-LXR4815-BREV.  
B

T-5mm (T-1 3/4) BLACK ANODIZED PANEL INDICATOR,  
WITH HARDWARE ASSEMBLY.

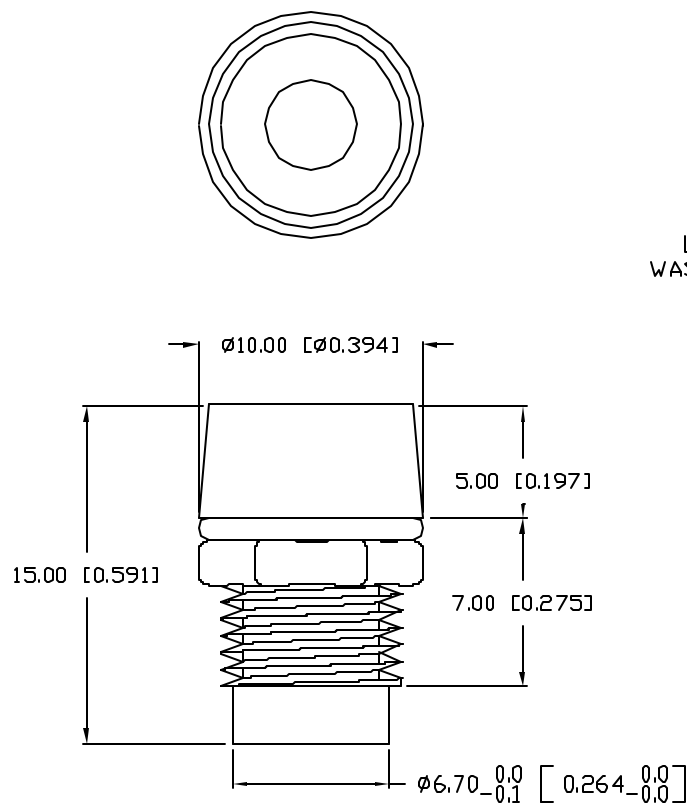
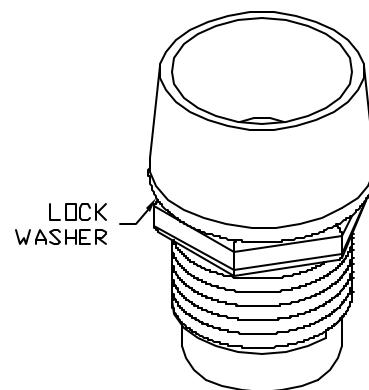
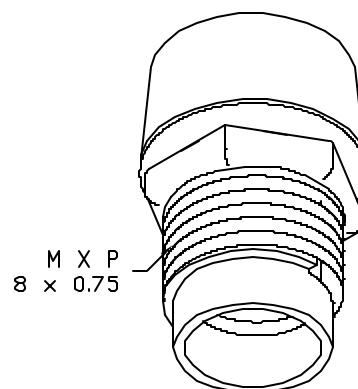
NOTES:  
1. BLACK ANODIZED FINISH.
