PART NUMBER  
LCD-H201M40TF-1D

| REV. | PART NUMBER |
|---|---|
| 2 DIGIT CUSTOM LCD GLASS PANEL, TN, TRANSFLECTIVE, TOP VIEW, NO PINS, EXTENDED OPERATING TEMPERATURE. | |

2 DIGIT CUSTOM LCD GLASS PANEL, TN, TRANSFLECTIVE,  
TOP VIEW, NO PINS, EXTENDED OPERATING TEMPERATURE.

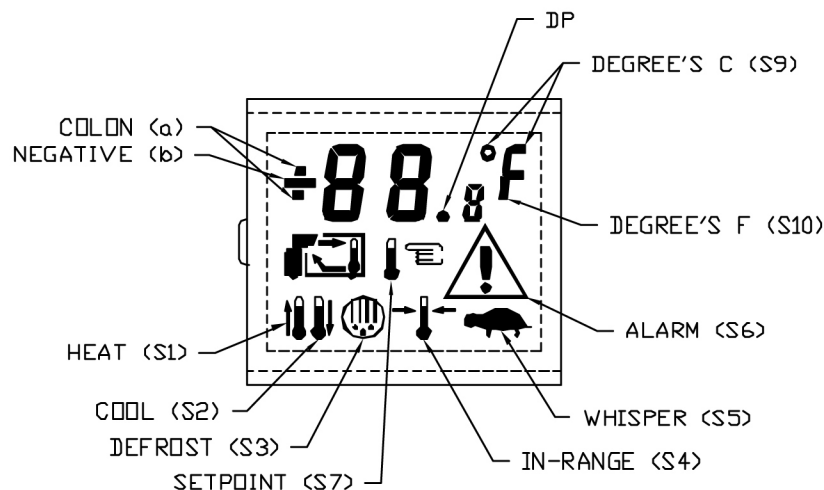
| PIN | SEG. | PIN | SEG. | PIN | SEG. | PIN | SEG. |
| 1 | COM | 10 | S7 | 19 | COM | 28 | 2G |
| 2 | b | 11 | S4 | 20 | 3G,3F | 29 | 1E |
| 3 | a | 12 | DP | 21 | 3G | 30 | 1D |
| 4 | X1 | 13 | 3B,3E | 22 | 2E | 31 | 1C |
| 5 | X2 | 14 | 3A,3D | 23 | 2D | 32 | 1B |
| 6 | S8 | 15 | S5 | 24 | 2C | 33 | 1A |
| 7 | S1 | 16 | S6 | 25 | 2B | 34 | 1F |
| 8 | S2 | 17 | S10 | 26 | 2A | 35 | 1G |
| 9 | S3 | 18 | S9 | 27 | 2F | 36 | COM |

- a - COLON  
 b - NEGATIVE  
 S1 - HEAT  
 S2 - COOL  
 S3 - DEFROST  
 S4 - IN RANGE  
 S5 - WHISPER  
 S6 - ALARM  
 S7 - SETPOINT  
 S8 - TRUCK  
 S9 - DEGREE'S C  
 S10 - DEGREE'S F  
 X1 - DISCHARGE AIR  
 X2 - RETURN AIR  
 DP - DECIMAL POINT

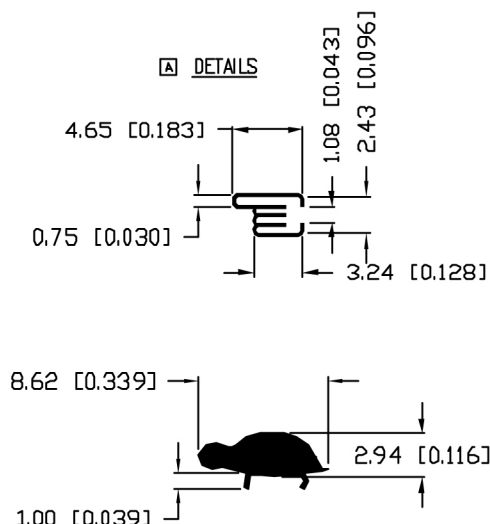
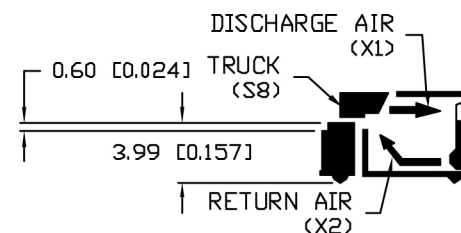
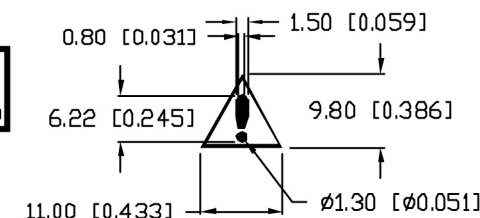
## A DETAILS

1. LINE THICKNESS FOR S3, AND S8 IS 0.40mm.
2. LINE THICKNESS FOR S6 IS 0.50mm AND SIZE IS INCREASED TO AS IN DETAIL.
3. REDUCE SIZE OF SETPOINT (S7), HAND ONLY. (SEE DETAILS)
4. INCREASE SIZE OF TURTLE (S5). (SEE DETAILS)
5. INCREASE SIZE OF FRONT CABIN OF TRUCK (S8). (SEE DETAILS)
