LCD-H2401M20TR-D

CUSTOM LCD PANEL, TN, REFLECTIVE,  
HIGH OPERATING TEMP, NO PINS.

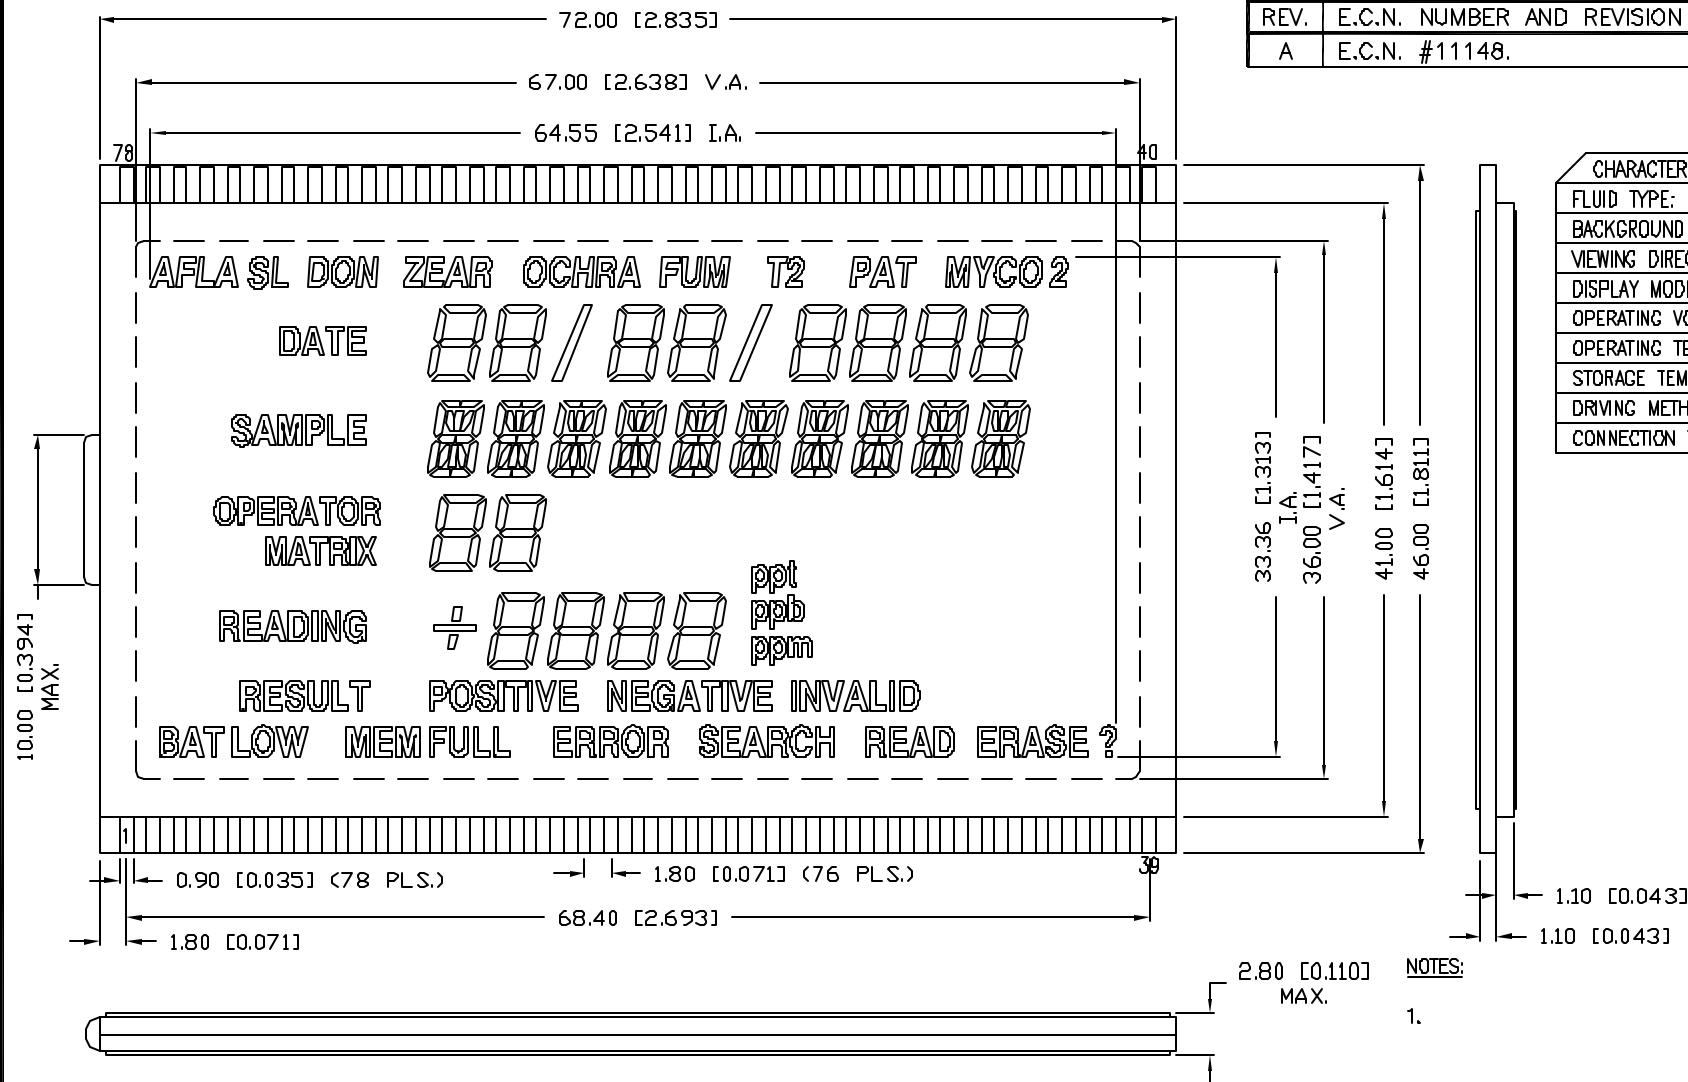
| CHARACTERISTICS | |
| FLUID TYPE: | TN |
| BACKGROUND COLOR: | GRAY |
| VIEWING DIRECTION: | 6:00 |
| DISPLAY MODE: | REFLECTIVE |
| OPERATING VOLTAGE: | 5.0 VOLTS |
| OPERATING TEMP. | -30°C TO +75°C |
| STORAGE TEMP. | -40°C TO +80°C |
| DRIVING METHOD: | 1/4 DUTY, 1/3 BIAS |
| CONNECTION TYPE: | ELASTOMER |

2.80 [0.110] MAX.
