LCD-H401M50KF-1

0.4" CUSTOM SEGMENT LCD DISPLAY,

3.0V TN POSITIVE, 12:00 VIEW, EXTENDED OPERATING TEMP.

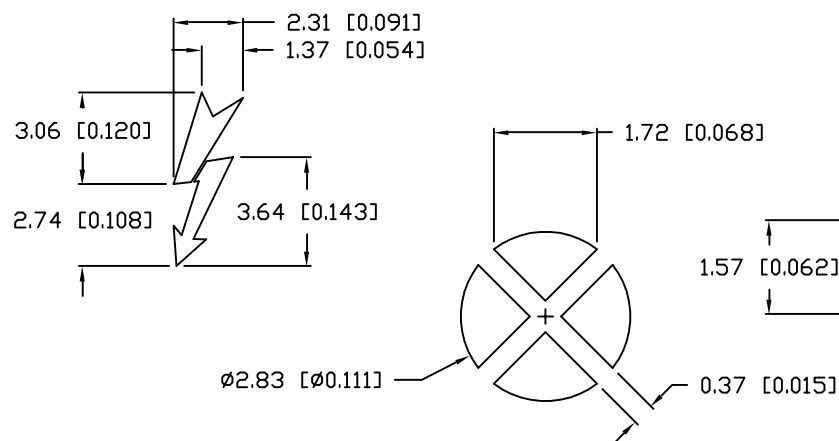
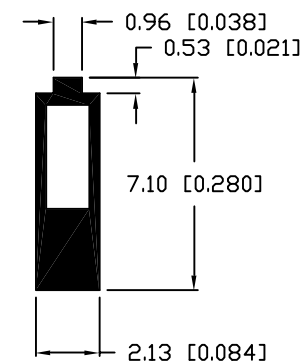
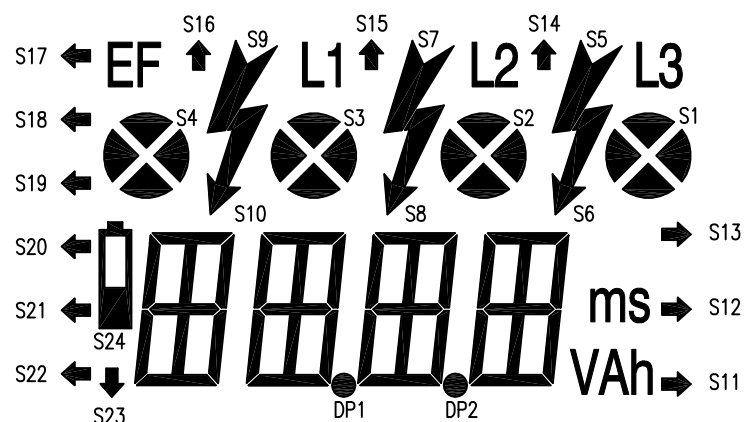
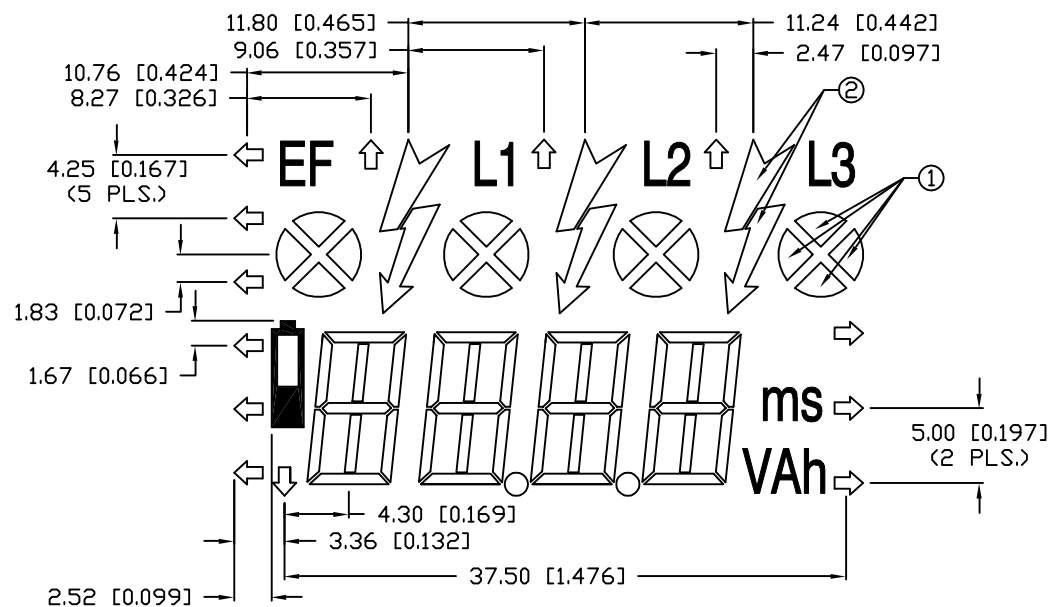
1. CIRCLE SEGMENTS, S1-S4 ARE EACH SINGLE SEGMENTS
2. FLASH ICON, AS S5 AND S6, ARE TWO SEGMENTS EACH.
3. m, s, V, A, h ARE ALL SEPERATE SEGMENTS.
