PART NUMBER  
LCD-H801M21TR-1

8 DIGIT CUSTOM LCD PANEL, TN, REFLECTIVE,  
12:00 VIEW, 1/4 DUTY, 1/3 BIAS, 3V A.C.,  
22 PINS, WIDE OPERATING TEMP.

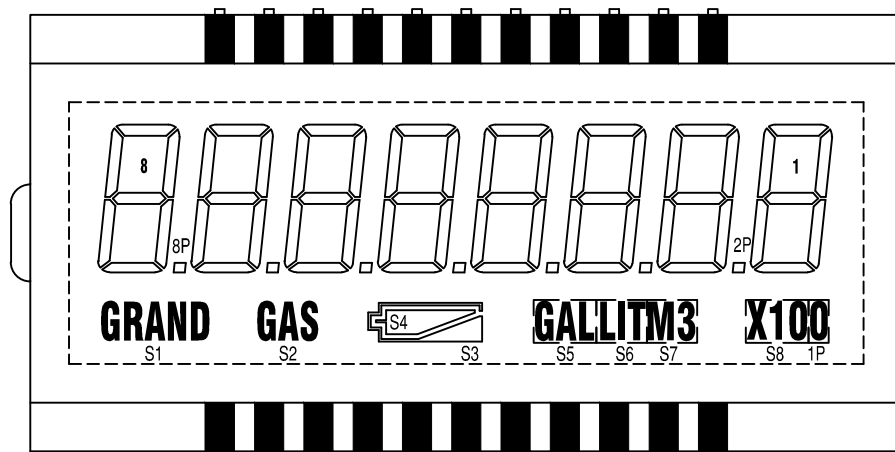
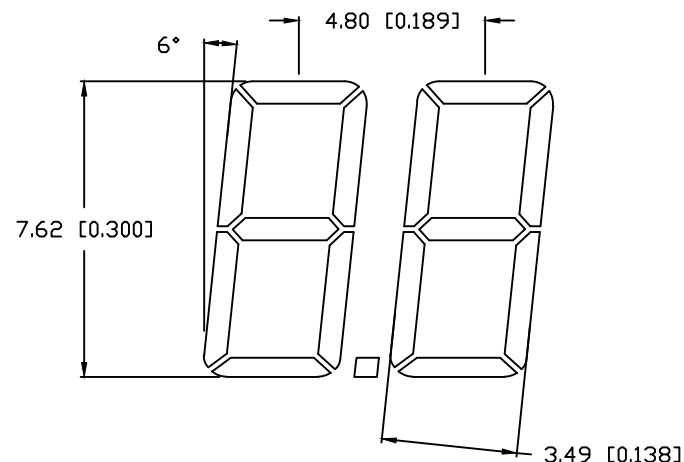
| PIN | 1 | 2 | 3 | 4 | 5 | 6 | 7 | 8 | 9 | 10 | 11 | 12 | 13 | 14 | 15 | 16 | 17 | 18 | 19 | 20 | 21 | 22 |
| COM1 | COM1 | | | | S4 | S5 | 1B | 1A | 2B | 2A | 3B | 3A | 4B | 4A | 5B | 5A | 6B | 6A | 7B | 7A | 8B | 8A |
| COM2 | | COM2 | | | S3 | S6 | 1G | 1F | 2G | 2F | 3G | 3F | 4G | 4F | 5G | 5F | 6G | 6F | 7G | 7F | 8G | 8F |
| COM3 | | | COM3 | | S2 | S7 | 1C | 1E | 2C | 2E | 3C | 3E | 4C | 4E | 5C | 5E | 6C | 6E | 7C | 7E | 8C | 8E |
| COM4 | | | | COM4 | S1 | S8 | 1P | 1D | 2P | 2D | 3P | 3D | 4P | 4D | 5P | 5D | 6P | 6D | 7P | 7D | 8P | 8D |
