PART NUMBER  
LCD-H801M39TRREV.  
B

8 DIGIT CUSTOM LCD PANEL, TN, REFLECTIVE,  
6:00 VIEW, 1/4 DUTY, 36 PINS, WIDE OPERATING TEMP.

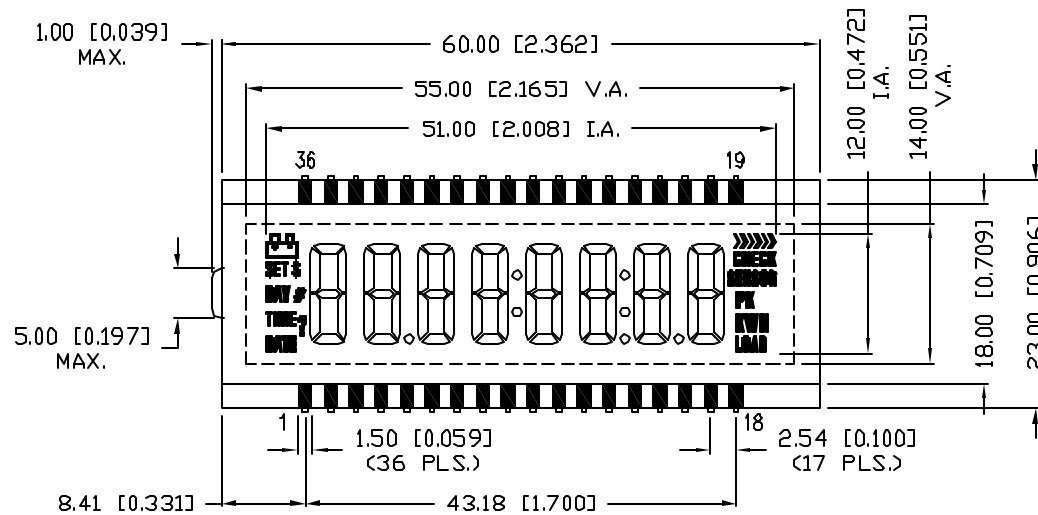
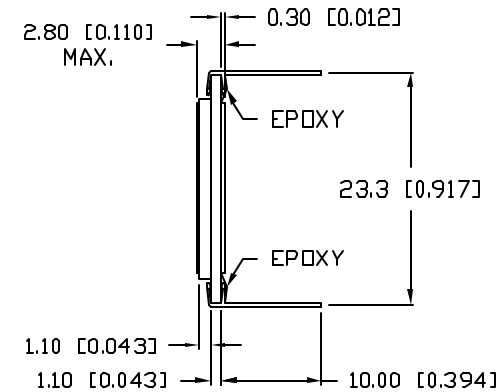
| CHARACTERISTICS | |
| FLUID TYPE | TN |
| BACKGROUND COLOR | GRAY |
| VIEWING DIRECTION | 6:00 |
| DISPLAY MODE | REFLECTIVE |
| OPERATING VOLTAGE | 5.0V A.C. |
| OPERATING TEMP. | -30°C TO 80°C |
| STORAGE TEMP. | -40°C TO 85°C |
| DRIVING METHOD | 1/4 DUTY, 1/3 BIAS |
| CONNECTION TYPE | 36 PINS |

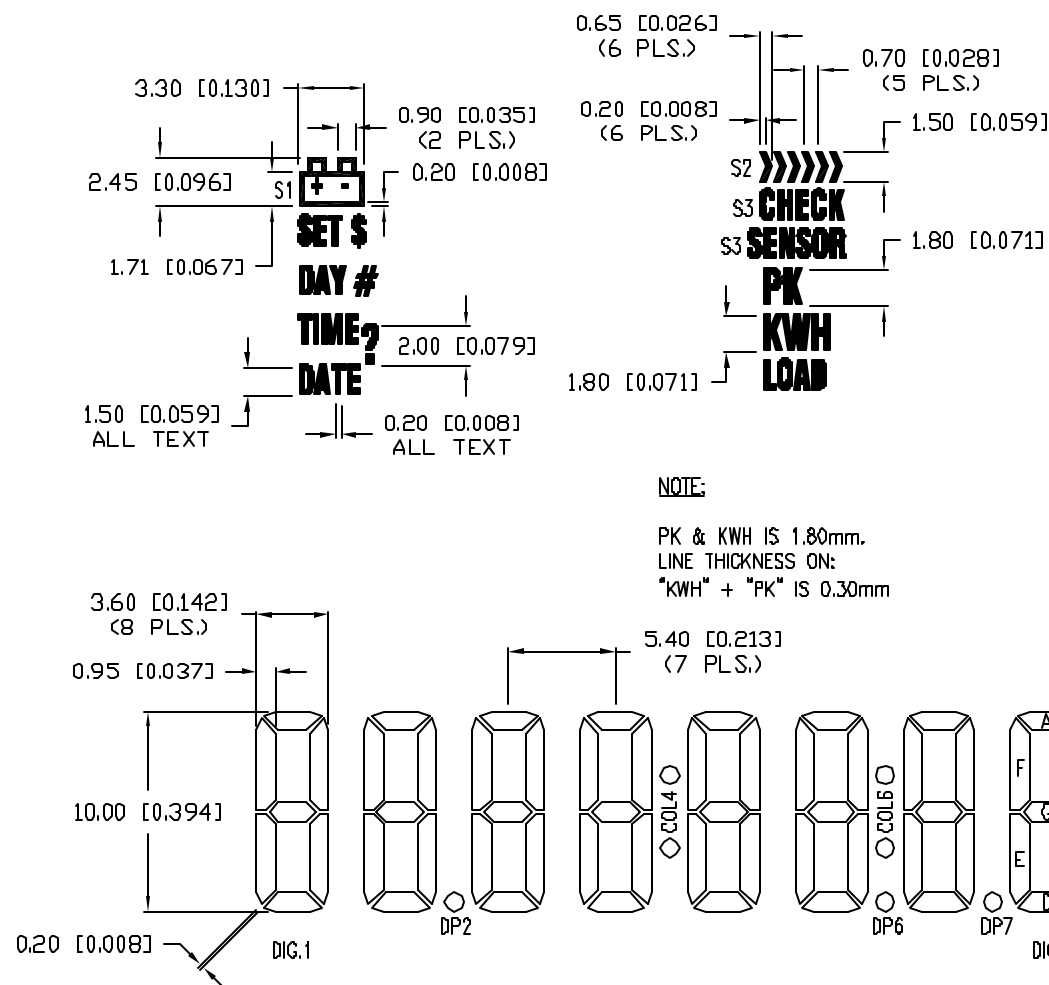
| 8 | SEE PAGE 1 |

PK & KWH IS 1.80mm.  
LINE THICKNESS ON:  
"KWH" + "PK" IS 0.30mm

| PIN NO. | 1 | 2 | 3 | 4 | 5 | 6 | 7 | 8 | 9 | 10 | 11 | 12 |
| COM1 | SET | 1A | 2A | 3A | 4A | - | 5A | - | 6A | - | 7A | - |
| COM2 | DAY | 1B | 2B | 3B | 4B | - | 5B | - | 6B | - | 7B | - |
| COM3 | TIME | 1C | 2C | 3C | 4C | - | 5C | - | 6C | - | 7C | - |
| COM4 | DATE | - | DP2 | - | - | - | COL4 | - | - | DP6 | COL6 | DP8 |
