LCD-S401M17TF

FOUR DIGIT 0.17" SEVEN SEGMENT, CUSTOM LCD PANEL,  
N, TRANSFLECTIVE, POSITIVE IMAGE, 0°C TO 50°C, 6:00 VIEW.

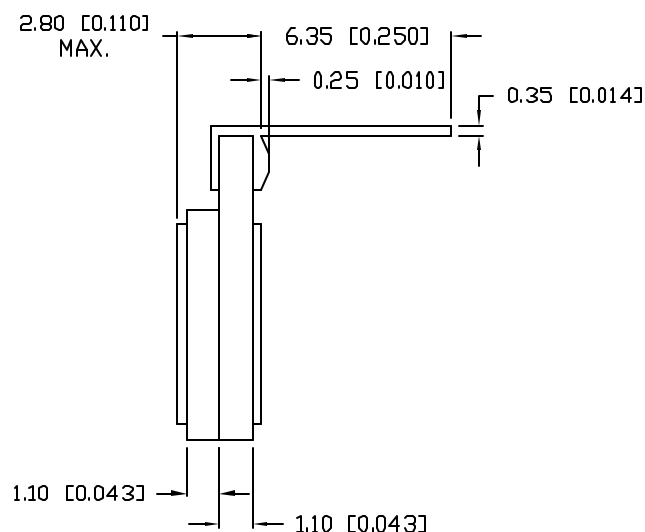
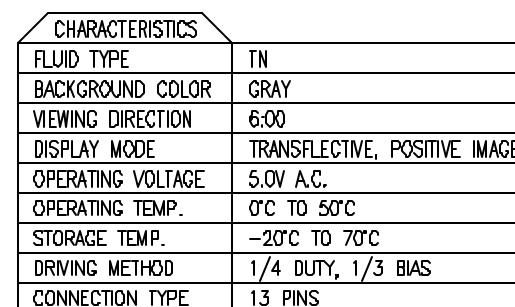
| PIN | 1 | 2 | 3 | 4 | 5 | 6 | 7 |
| COM0 | COM0 | / | / | / | 1D | DP1 | 2D |
| COM1 | / | COM1 | / | / | 1E | 1C | 2E |
| COM2 | / | / | COM2 | / | 1G | 1B | 2G |
| COM3 | / | / | / | COM3 | 1F | 1A | 2F |
| PIN | 8 | 9 | 10 | 11 | 12 | 13 | |
| COM0 | DP2 | 3D | DP3 | 4D | / | ON DELAY | |
| COM1 | 2C | 3E | 3C | 4E | 4C | OFF DELAY | |
| COM2 | 2B | 3G | 3B | 4G | 4B | ONE SHOT | |
| COM3 | 2A | 3F | 3A | 4F | 4A | / | |
