PART NUMBER  
LCD-U1302M67TF-1REV.  
A

14 DIGIT CUSTOM LCD PANEL, TN, TRANSFLECTIVE, 12:00 VIEW,  
-40°C ~ 85°C OPERATING TEMP, 40 PINS.

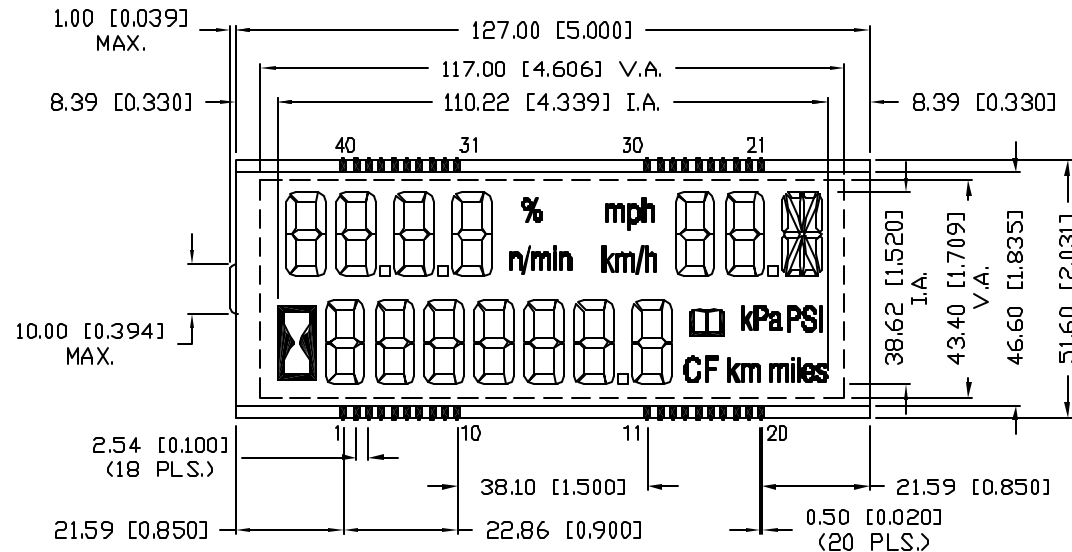
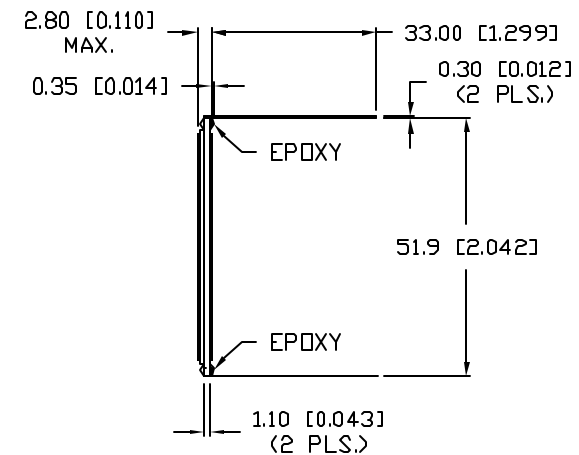
| CHARACTERISTICS | |
| FLUID TYPE: | TN |
| BACKGROUND COLOR: | NEUTRAL |
| VIEWING DIRECTION: | 12:00 |
| DISPLAY MODE: | TRANSFLECTIVE |
| OPERATING VOLTAGE: | 5.0V A.C. |
| OPERATING TEMP. | -40°C TO 85°C |
| DRIVING METHOD: | 1/4 DUTY, 1/3 BIAS. |
| CONNECTION TYPE: | 40 PINS |

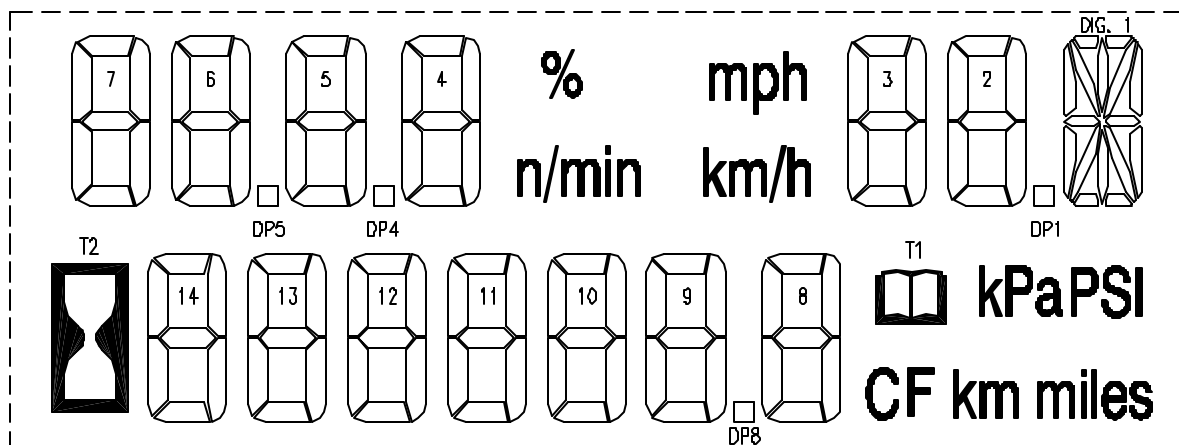
| PIN NO. | 1 | 2 | 3 | 4 | 5 | 6 | 7 | 8 | 9 | 10 | 11 | 12 | 13 | 14 |
| COM1 | T2 | 14D | / | 13D | / | 12D | / | 11D | / | 10D | / | 9D | DP8 | 8D |
| COM2 | 14E | 14C | 13E | 13C | 12E | 12C | 11E | 11C | 10E | 10C | 9E | 9C | 8E | 8C |
| COM3 | 14G | 14B | 13G | 13B | 12G | 12B | 11G | 11B | 10G | 10B | 9G | 9B | 8G | 8B |
| COM4 | 14F | 14A | 13F | 13A | 12F | 12A | 11F | 11A | 10F | 10A | 9F | 9A | 8F | 8A |
| PIN NO. | 15 | 16 | 17 | 18 | 19 | 20 | 21 | 22 | 23 | 24 | 25 | 26 | 27 | 28 |
| COM1 | DP1 | C | COM1 | / | / | / | COM1 | / | / | / | 1C | 1M | 1D1 | 1D2 |
| COM2 | T1 | F | / | COM2 | / | / | / | COM2 | / | / | 1N | 1L | 1K | 1E |
| COM3 | kPa | km | / | / | COM3 | / | / | / | COM3 | / | 1B | 1I | 1J | 1F |
| COM4 | PSI | miles | / | / | / | COM4 | / | / | / | COM4 | 1A2 | 1H | 1A1 | 1G |
| PIN NO. | 29 | 30 | 31 | 32 | 33 | 34 | 35 | 36 | 37 | 38 | 39 | 40 | | |
| COM1 | 2D | km/h | 3D | mph | 4D | DP4 | 5D | DP5 | 6D | % | 7D | n/min | | |
| COM2 | 2C | 2E | 3C | 3E | 4C | 4E | 5C | 5E | 6C | 6E | 7C | 7E | | |
| COM3 | 2B | 2G | 3B | 3G | 4B | 4G | 5B | 5G | 6B | 6G | 7B | 7G | | |
| COM4 | 2A | 2F | 3A | 3F | 4A | 4F | 5A | 5F | 6A | 6F | 7A | 7F | | |

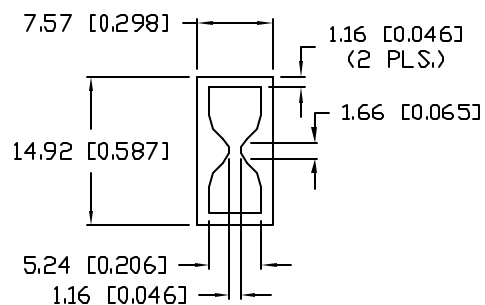
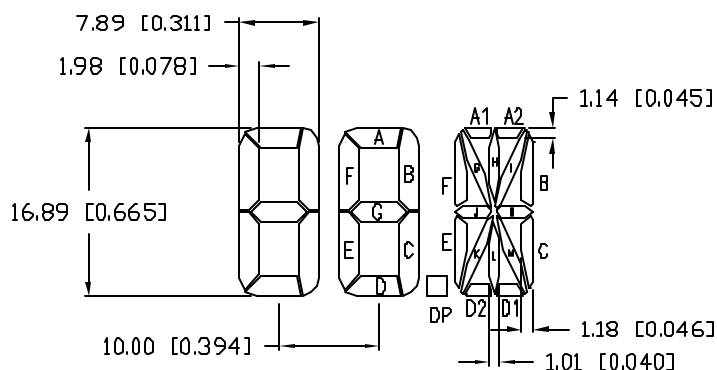
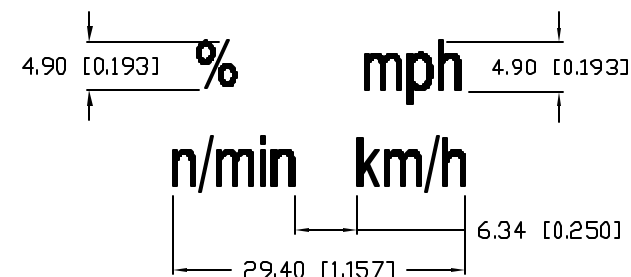
| 14 DIGIT CUSTOM LCD PANEL, TN, TRANSFLECTIVE, 12:00 VIEW,<br>-40°C ~ 85°C OPERATING TEMP, 40 PINS. | | RELIABILITY NOTE<br>OUR MANY YEARS OF EXPERIENCE DATA ACCUMULATION INDICATE THAT SOLDER HEAT IS A MAJOR CAUSE OF EARLY AND FUTURE FAILURE. PLEASE PAY ATTENTION TO YOUR SOLDERING PROCESS. | | DRAWN BY:<br>JC | CHECKED BY:<br>APPROVED BY:<br>DATE: 10.15.03<br>PAGE: 3 OF 3<br>SCALE: N/A |
