LCM-S02004DSF/GY1P

4.99mm CHARACTER HEIGHT, 20 x 4 CHARACTER LCD  
MODULE, TOP VIEW, STN, YELLOW-GREEN BACKGROUND,  
TRANSFLECTIVE W/LED BACKLIGHT, 1/33 DUTY, 16 PINS.

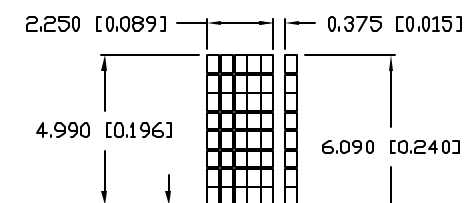
## CHARACTER DETAIL

TOP & BOTTOM= 1.100 [0.043]  
MIDDLE GAP= 1.575 [0.062]  
2.625 [0.103]
