LDS-A324RO

0.36" SEVEN SEGMENT, LED DISPLAY, COMMON ANODE, 635nm RED CHIPS, RED FACE WITH RED SEGMENTS.

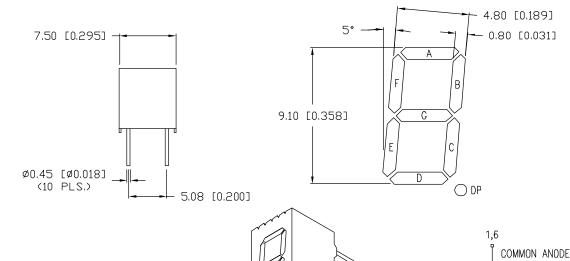
PIN 1 —

PIN 5

∠ PIN 10

→ PIN 6

2.54 [0.100] _ (4 PLS.)
