PART NUMBER  
LLP-LXC02030SS23

Ø3mm, TWO CIRCULAR UNITS, VERTICAL LIGHT PIPE.

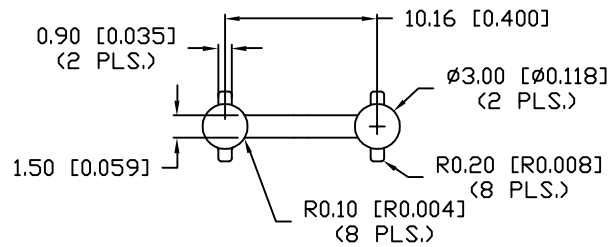
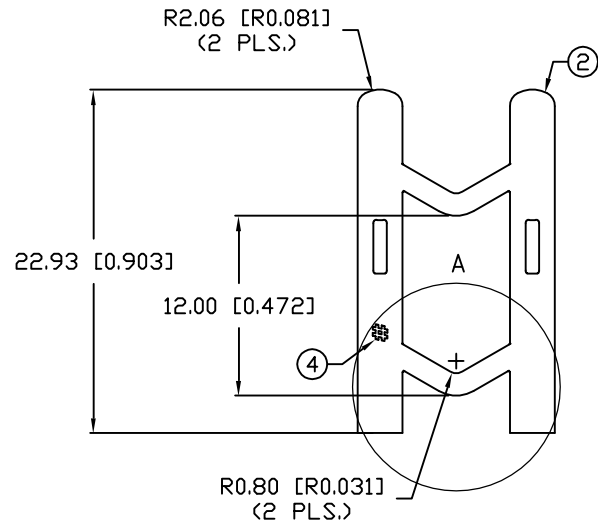
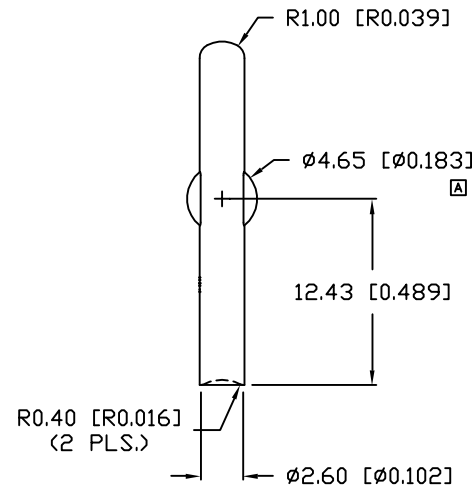
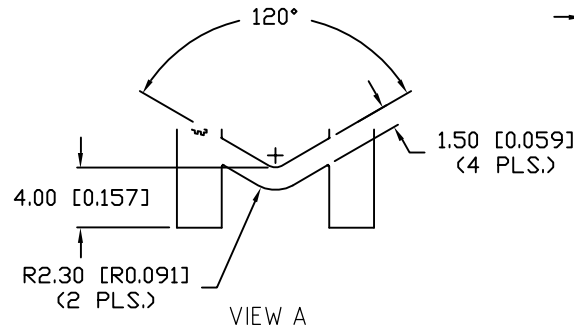
1. MATERIAL: CLEAR POLYCARBONATE.
2. DIFFUSED TEXTURE.
3. LIGHT PIPE TO BE FREE OF BUBBLES.
4. CAVITY NUMBER.
