| PART NUMBER | | REV. |
|---|---|---|
| LPF-R011331S | | C |

| REV. | PART NUMBER | CONFIDENTIAL INFORMATION | | LUMEX | | 290 E. HELEN ROAD | |
|---|---|---|--|---|--|---|--|
| CUSTOM LIGHT PIPE. | | RELIABILITY NOTE<br>OUR MANY YEARS OF EXPERIENCE DATA ACCUMULATION INDICATE THAT SOLDER HEAT IS A MAJOR CAUSE OF EARLY AND FUTURE FAILURE. PLEASE PAY ATTENTION TO YOUR SOLDERING PROCESS. | | DRAWN BY: GB | | CHECKED BY: | |

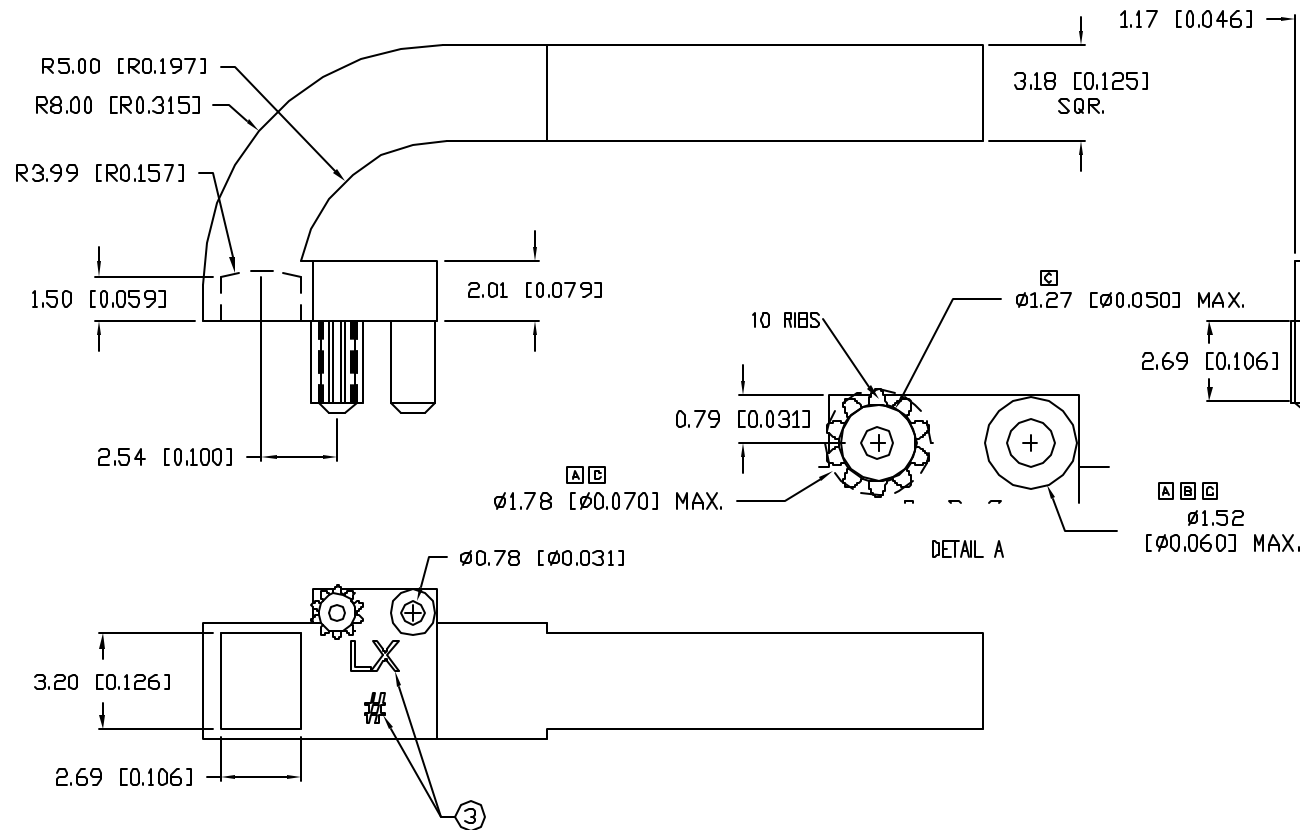
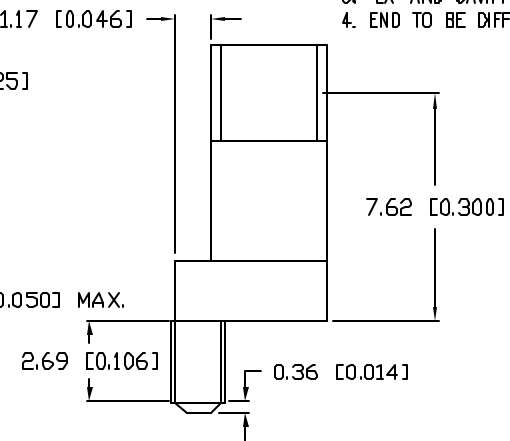
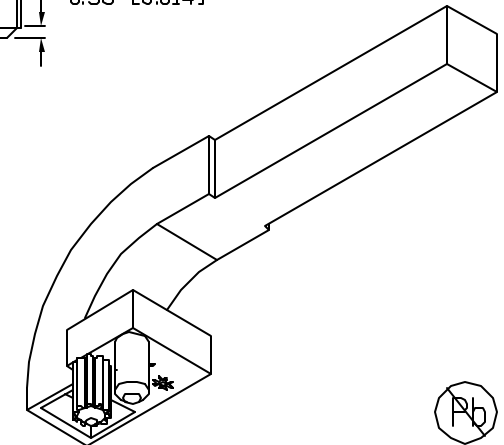
1. MATERIAL: CLEAR POLYCARBONATE, 94V-0.
2. LIGHT PIPE TO BE FREE OF BUBBLES.
3. 'LX' AND CAVITY MARK.
4. END TO BE DIFFUSED.
