OED-HPI4439B-TR

SMT PHOTODIODE, 4.4 x 3.9mm PACKAGE  
WITH DAYLIGHT FILTER.

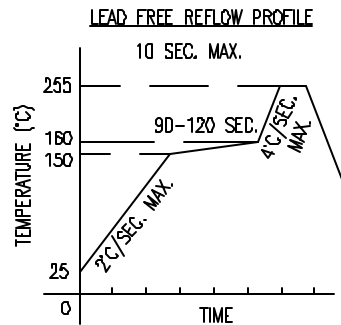
TOTAL TIME ABOVE 220°C IS 60 SECONDS MAX.
